POLLUTION SURVEY SWASTIKA AREA TOWN OF KIRKLAND LAKE (TOWNSHIP OF TECK)

POLLUTION SURVEY

SWASTIKA AREA

July 1975
Municipal & Private Abatement
Timmins District
Northeastern Region

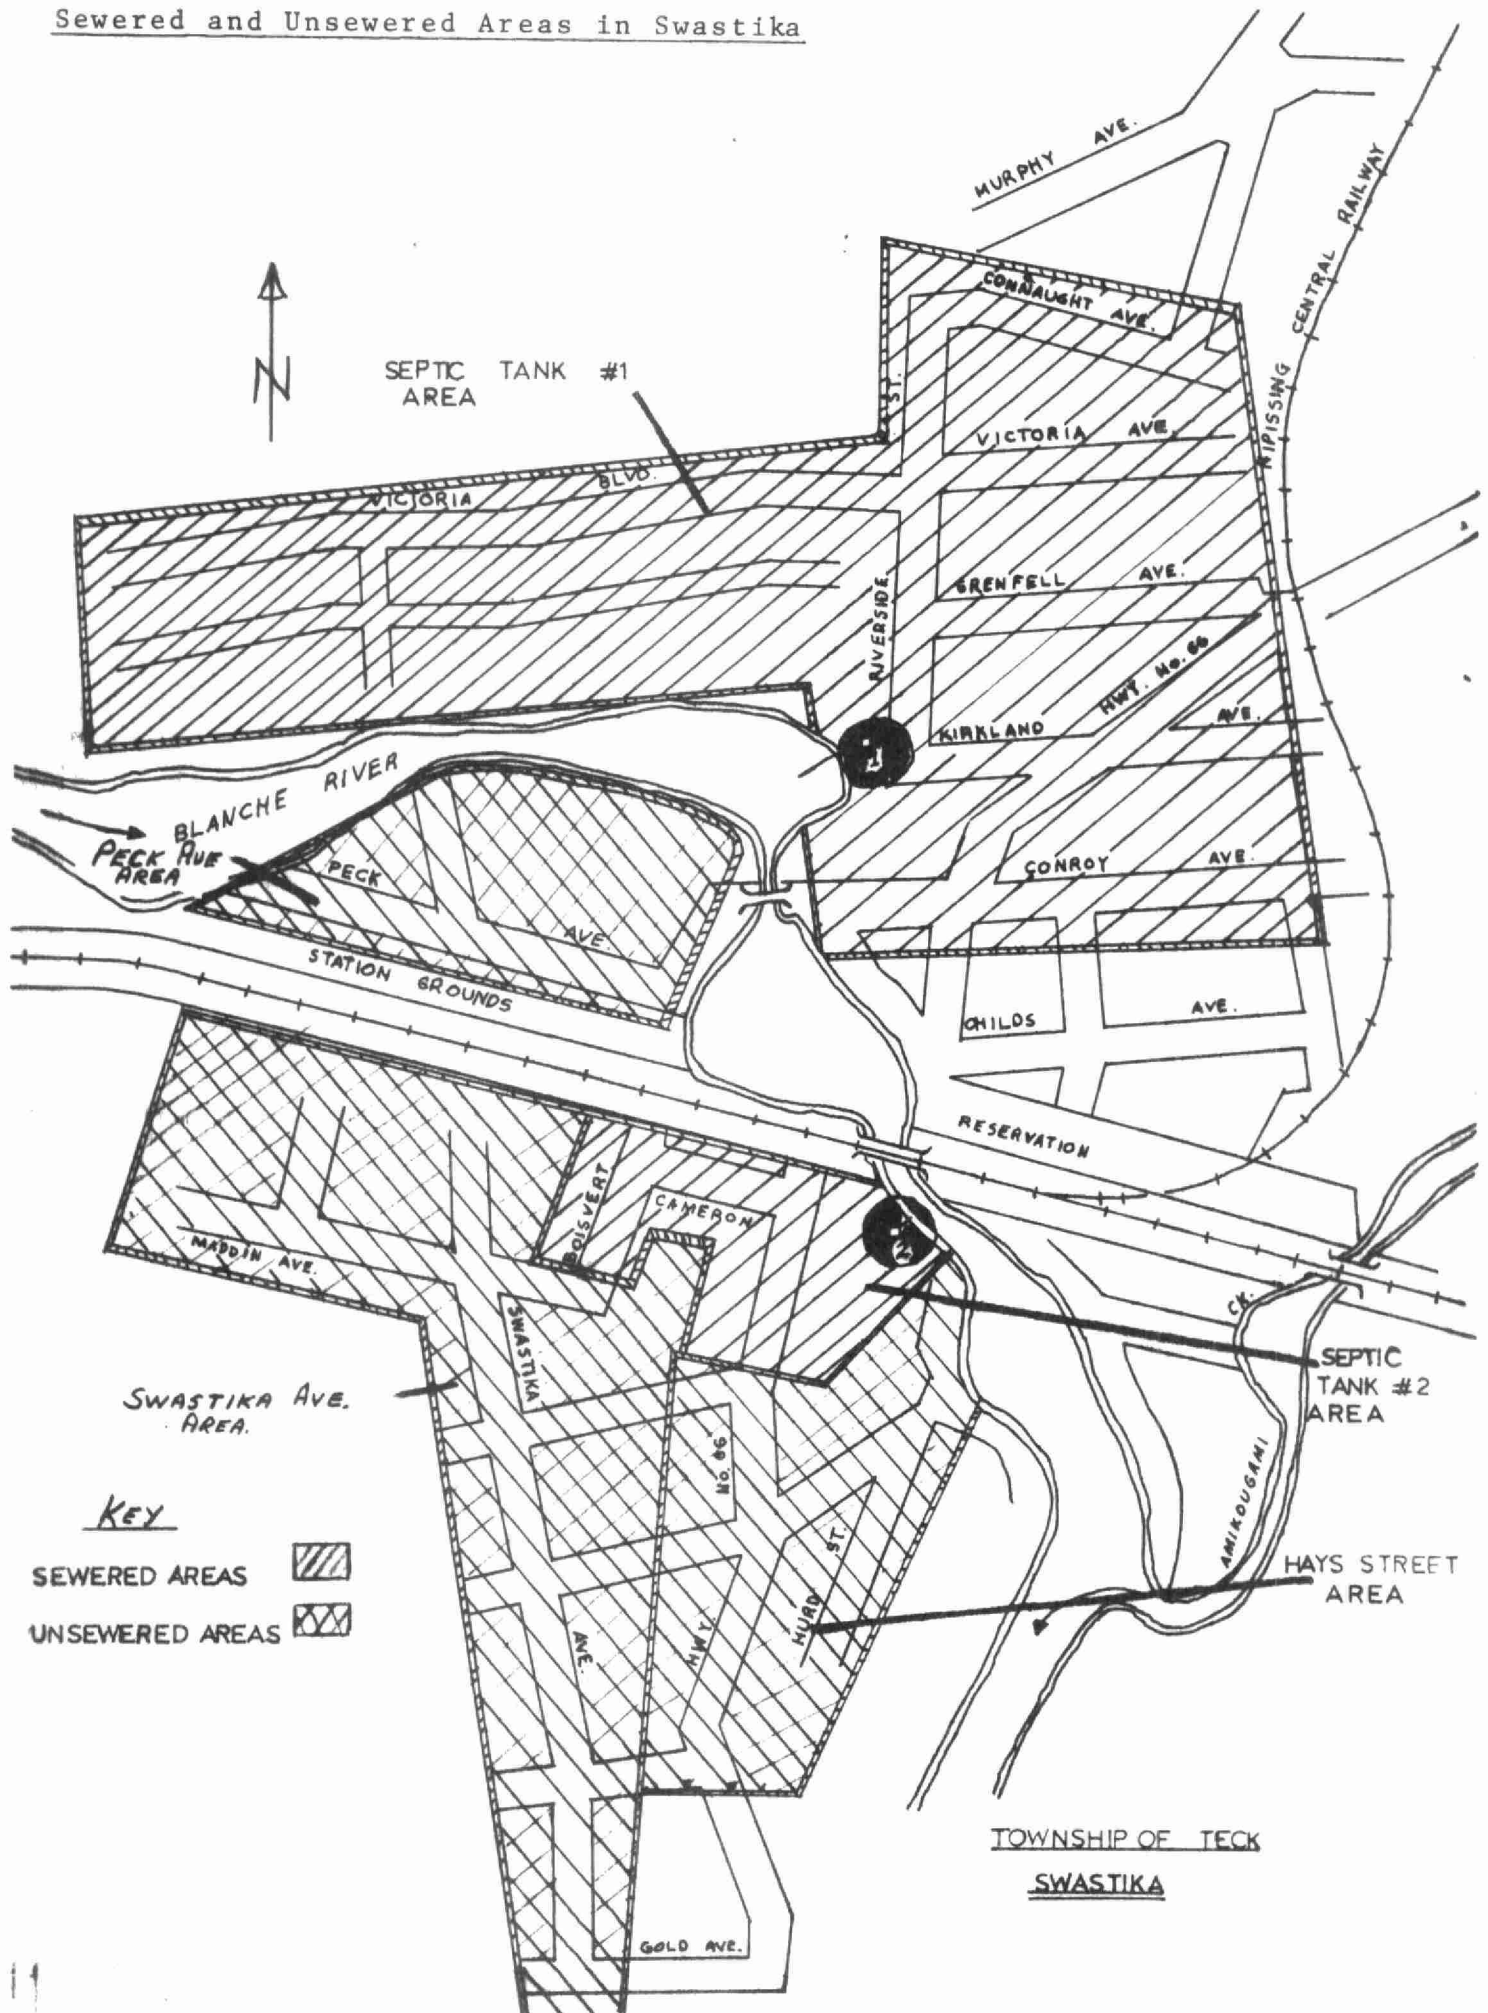
Sewered and Unsewered Areas in Swastika

To facilitate easy reference a small map of Swastika has been included on the next page. Five of the six study areas are shown on this map. The sewered areas serviced by Septic Tank #1 and Septic Tank #2 are shown along with the following unsewered areas:

Peck Avenue
Swastika Avenue
and Hays Street.
